**First National Bank, Sasolburg,
South Africa**

CASE STUDY

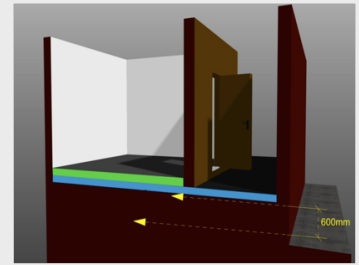
The bank vault was out of level which caused the door to self close; The 30 ton safe had subsided by 14mm on the left hand side of the door opening caused by badly compacted fill; Due to the fact that the floor of the vault is constructed of 2 layers 50mm steel plate with concrete infill, this prevented drilling vertically through the floor.

The drilling operation was executed horizontally from the exterior of the building, a number of pipes were inserted 600mm below floor level and directly below the concrete floor slab on the two sides, in varying lengths, reaching to the centre of the vault towards the subsided corner.

The whole operation took 5 hours and the floor was successfully raised by 11mm achieving optimal lift for the door to function correctly.
